Windstorm Mitigation Report

Lake Overlook Unit 4

St. Petersburg, FL

As of 8/16/2021 | FPAT File# MUD2116358

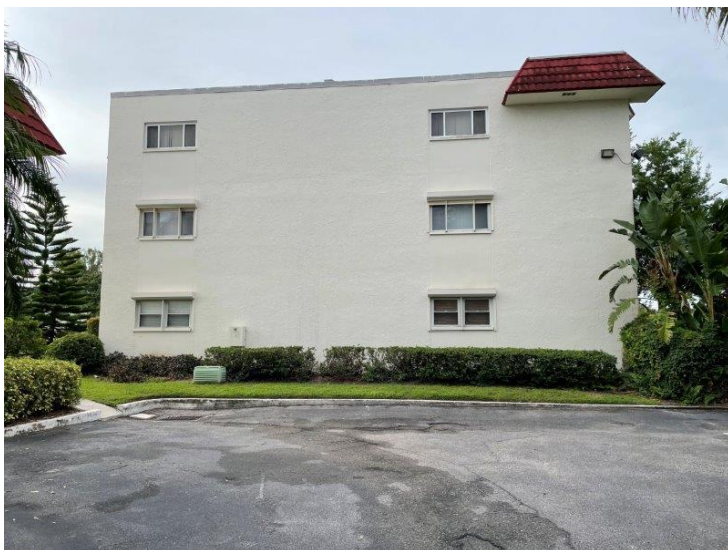
Exterior Elevation

Comments: | None or Some Glazed Openings
Inspection verified some metal shutter opening protection. Not all glazed openings were protected with impact resistant coverings. |

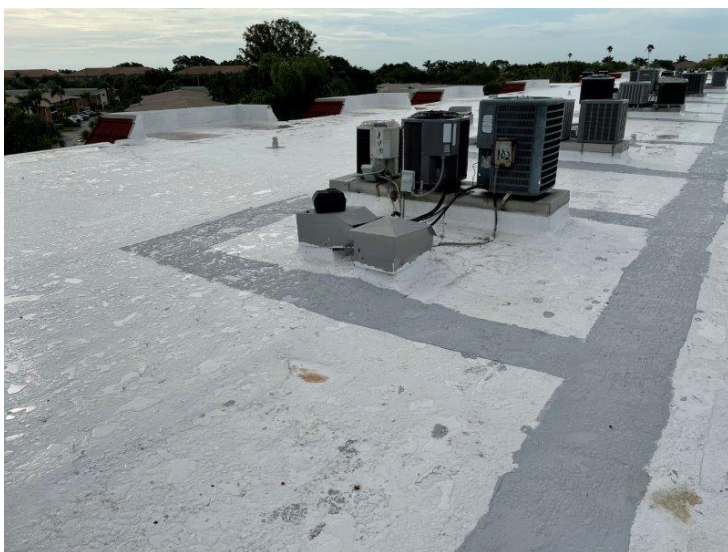
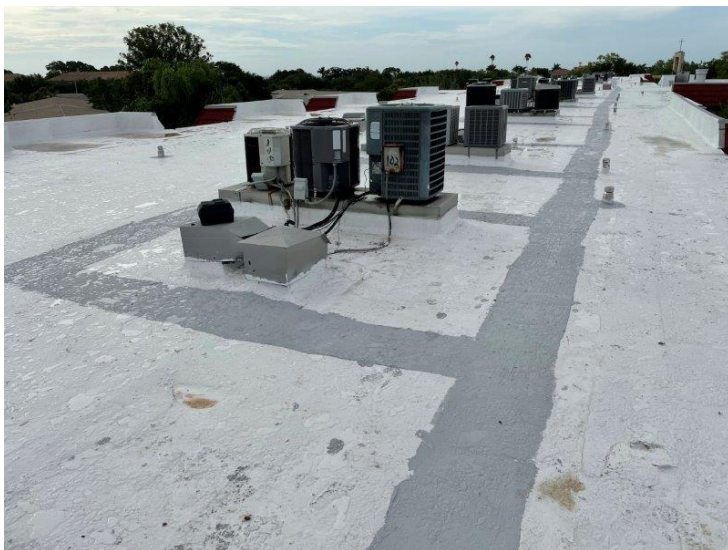
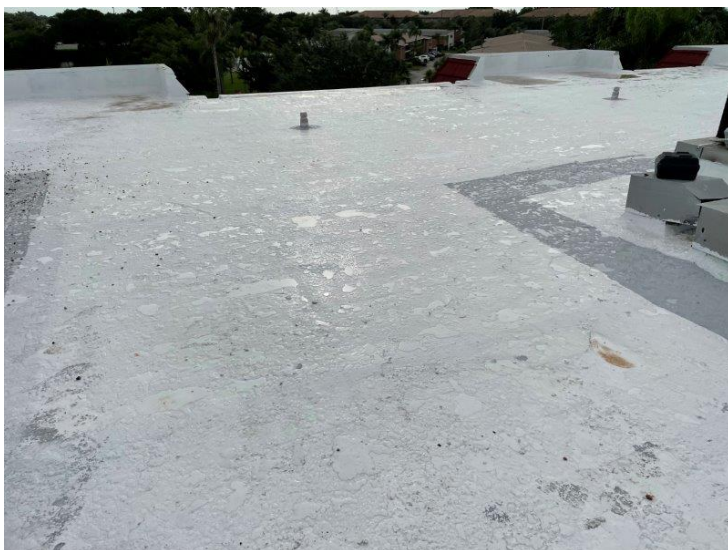
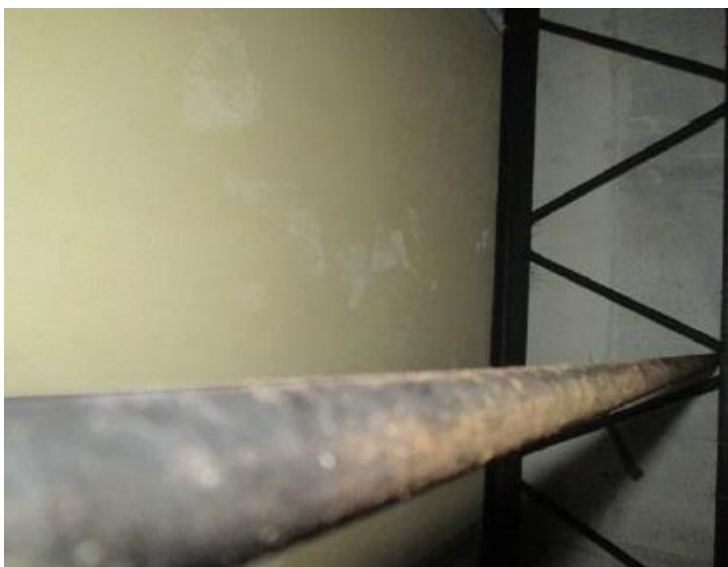
Roof Construction

Comments: | No roof coverings meet the minimum requirements
The roof covering was replaced in 1999. The roof permit was confirmed and the permit number is 99-12000874. The roof was coated with a silicone coating in 2021. This roof was verified as not meeting the building code requirements outlined on the mitigation affidavit. |

Comments: | Other
Inspection verified a roof deck composed of lightweight concrete poured in metal pans supported by steel bar joists. |

Comments: | Structural
Inspection verified a roof-wall connection composed of steel bar joists structurally connected to the wall/support system. |

Comments: | Flat Roof
Inspection verified a flat roof shape. |

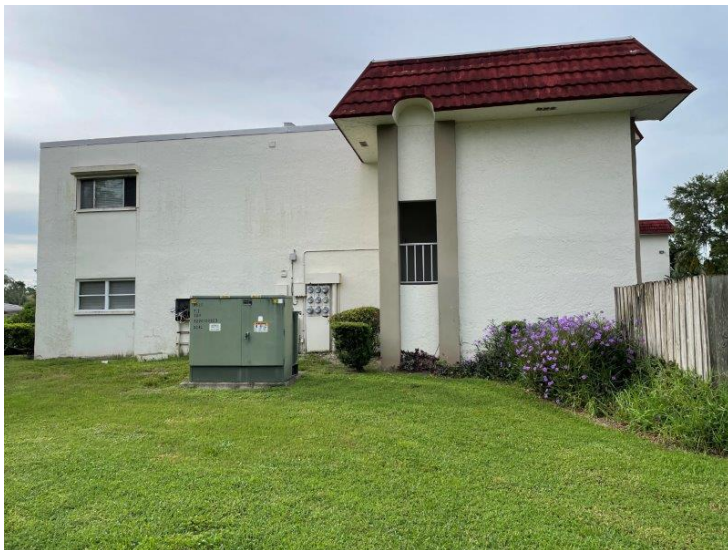
Exterior Elevation

- 7. Opening Protection:** **None or Some Glazed Openings**
Comments: Inspection verified some metal shutter opening protection. Not all glazed openings were protected with impact resistant coverings.

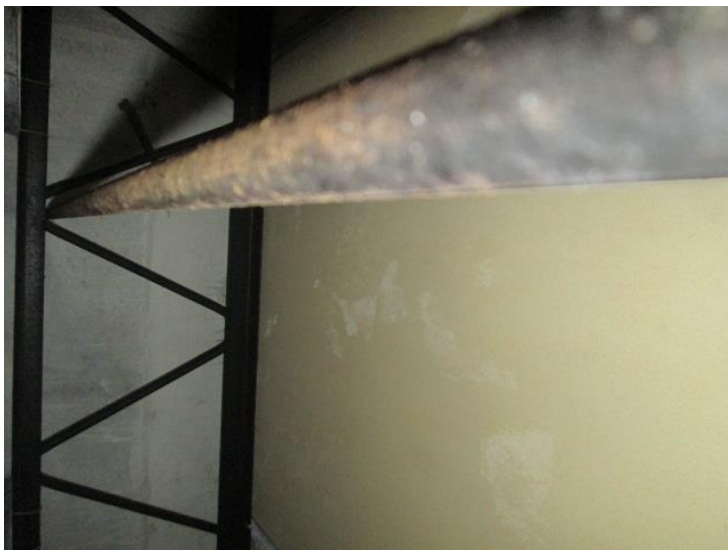
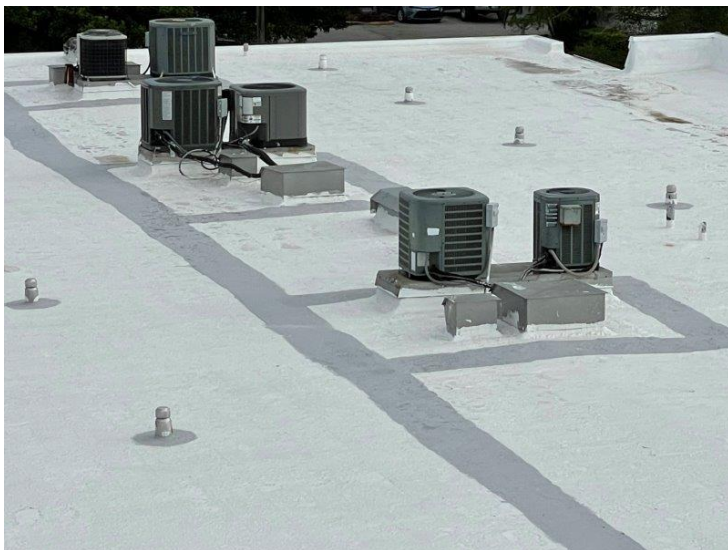
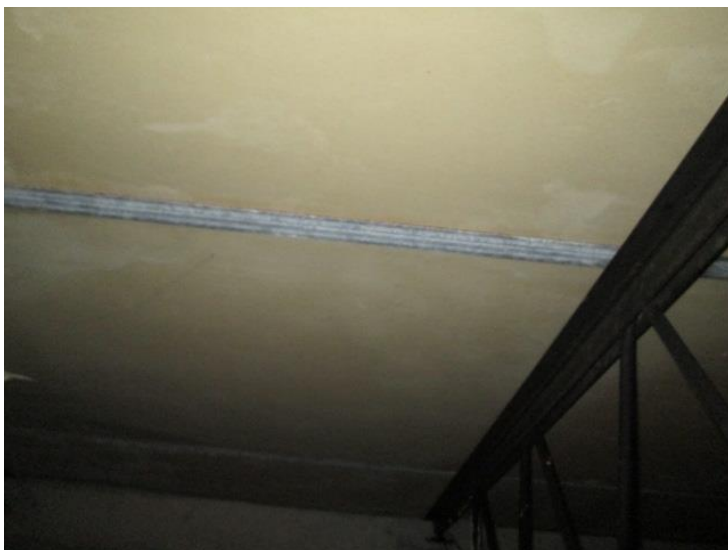
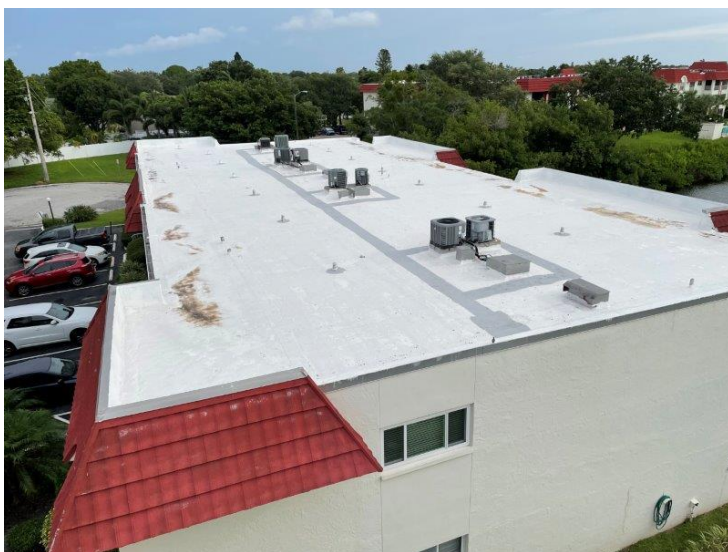
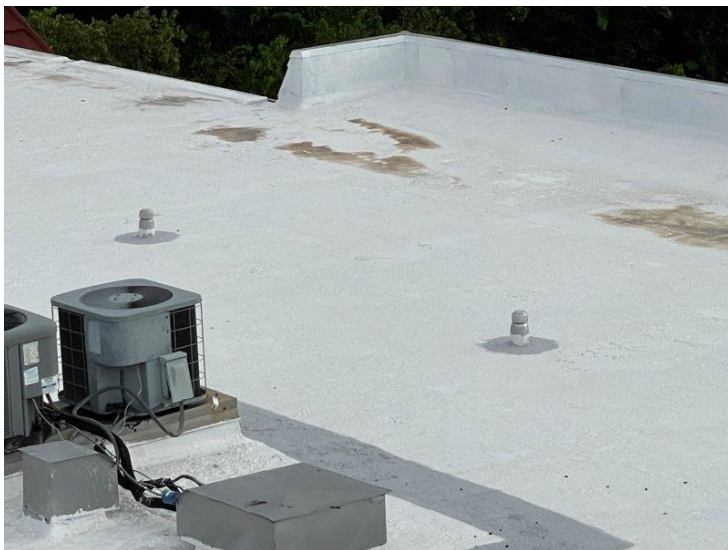
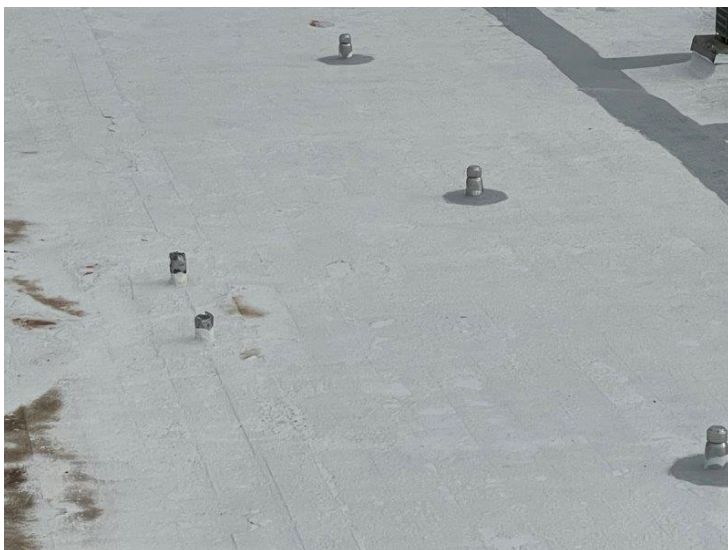
Roof Construction

- 2. Roof Covering:** **No roof coverings meet the minimum requirements**
Comments: The roof covering was replaced in 1999. The roof permit was confirmed and the permit number is 99-12000874. The roof was coated with a silicone coating in 2021. This roof was verified as not meeting the building code requirements outlined on the mitigation affidavit.

- 3. Roof Deck Attachment:** **Other**
Comments: Inspection verified a roof deck composed of lightweight concrete poured in metal pans supported by steel bar joists.

- 4. Roof to Wall Attachment:** **Structural**
Comments: Inspection verified a roof-wall connection composed of steel bar joists structurally connected to the wall/support system.

- 5. Roof Geometry:** **Flat Roof**
Comments: Inspection verified a flat roof shape.
- 6. SWR:** **No**
Comments: SWR does not apply to concrete roof decks.
