# Windstorm Mitigation Affidavit Report

Form OIR-B1-1802 (Rev.04/26)

Lake Overlook Unit 4  
4595 Chancellor St NE, 101-114, 215-228, 329-342  
St. Petersburg, FL 33703

Prepared Exclusively for Lake Overlook Unit 4 Association, Inc.  
As of 06-15-2026 | FPAT File# MUD2627086

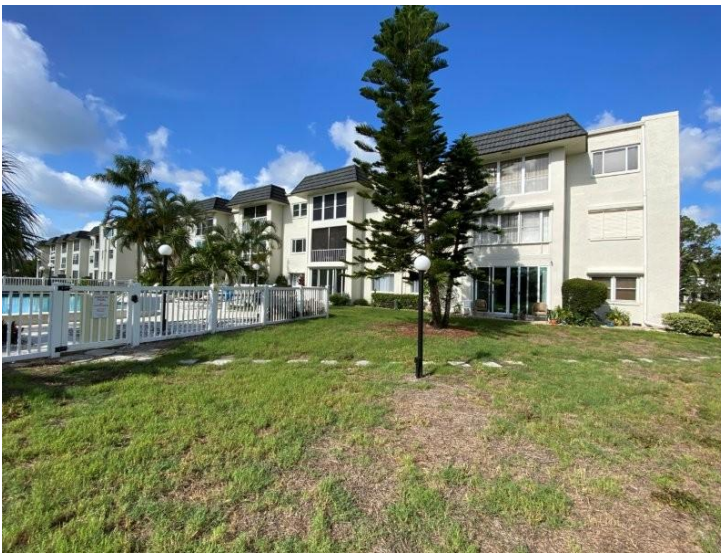
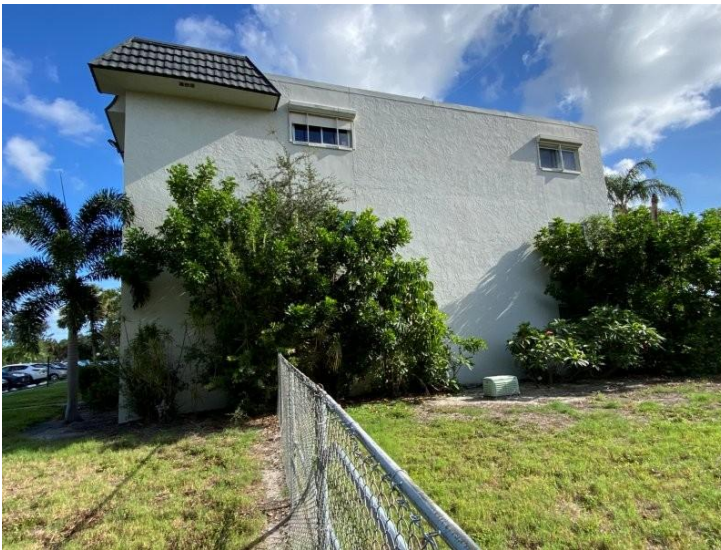
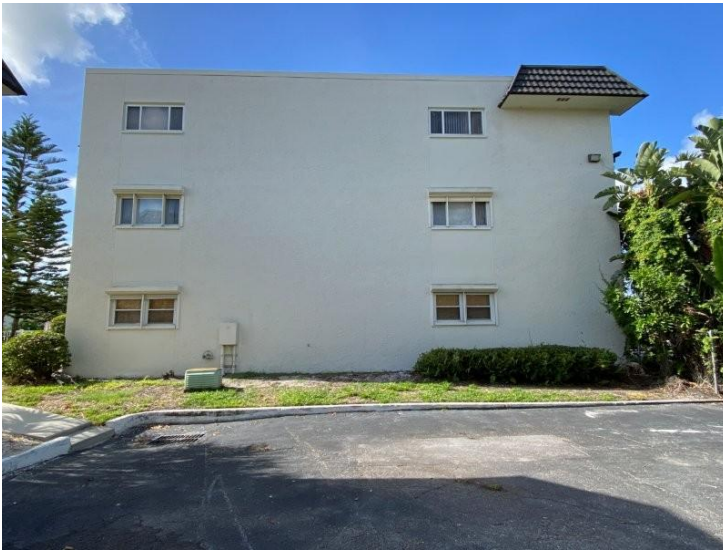
Exterior Elevation

| <b>9. Opening Protection:</b><br>Comments: | <b>X. None or Some Glazed Openings</b><br>Inspection verified some opening protection. Not all glazed openings were protected with impact resistant coverings. |

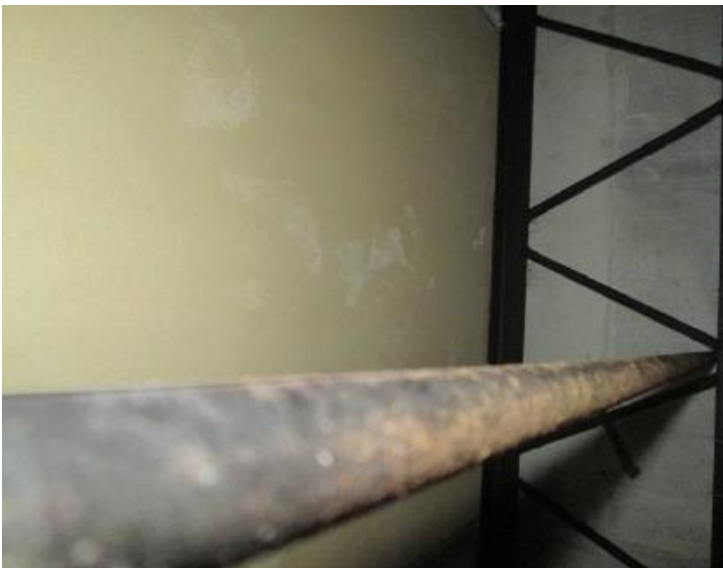
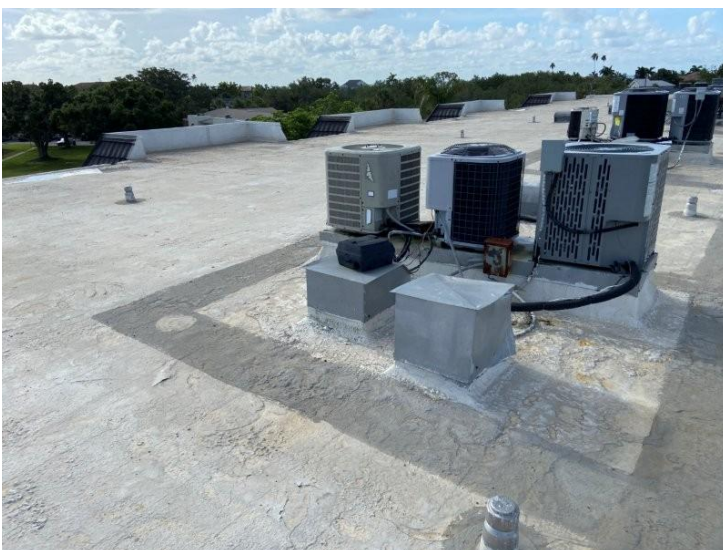
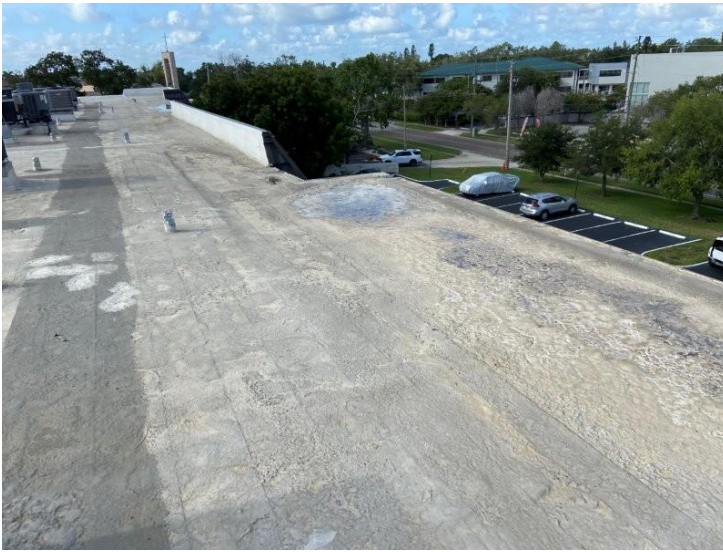
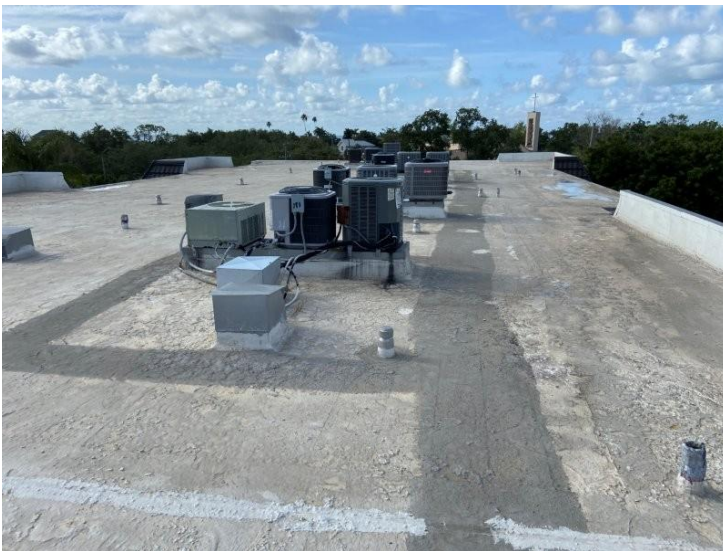
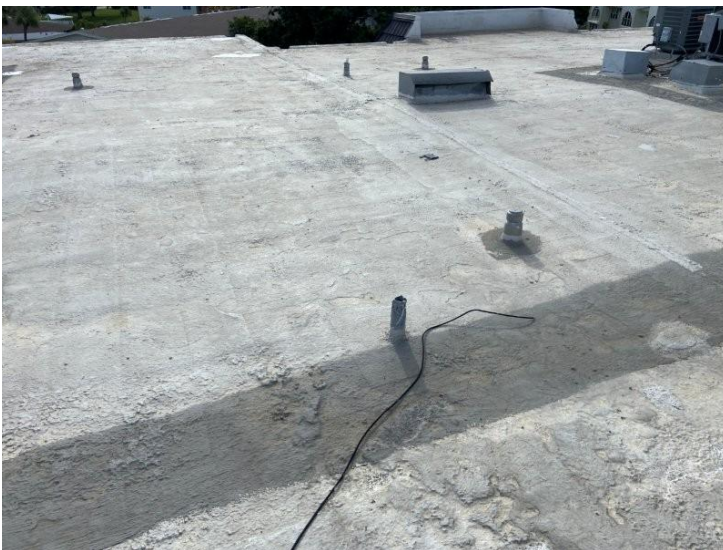
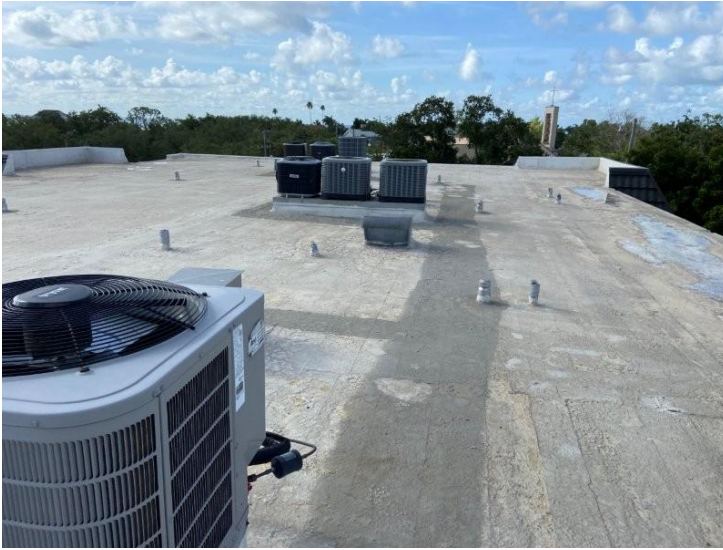
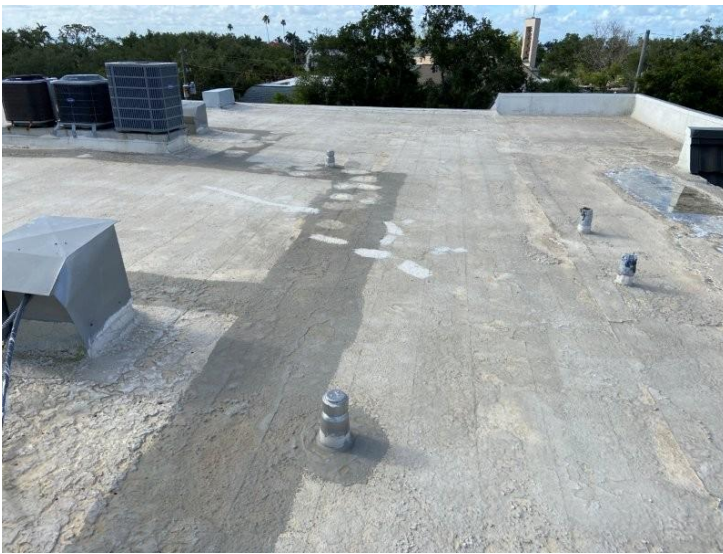
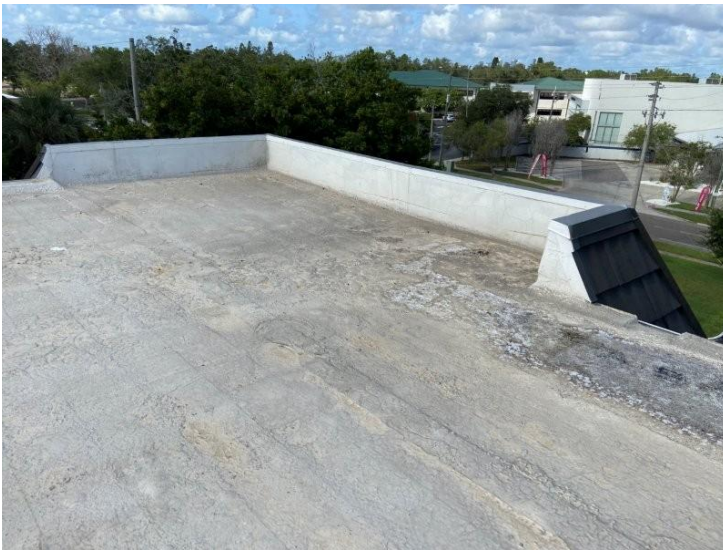
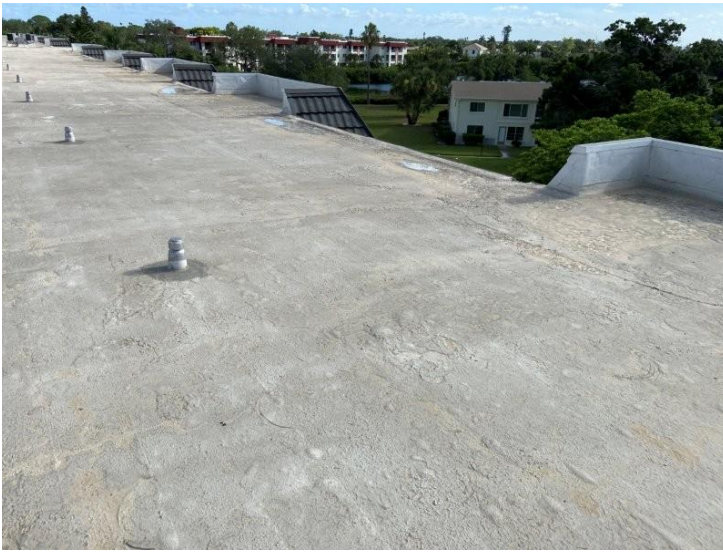
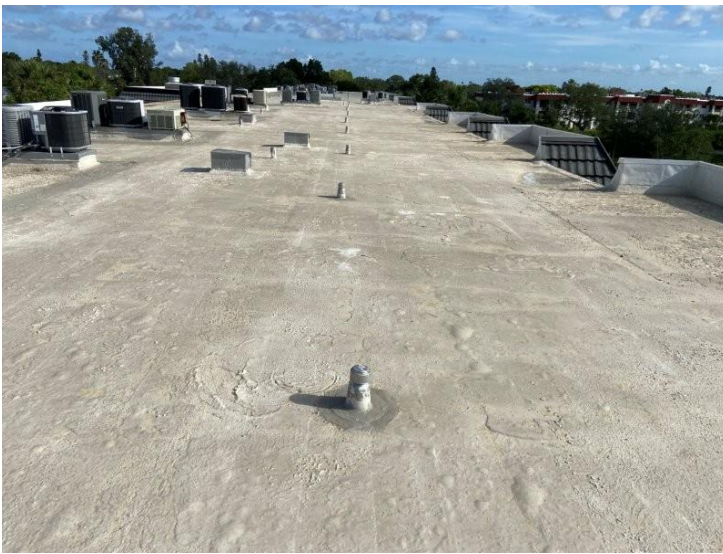
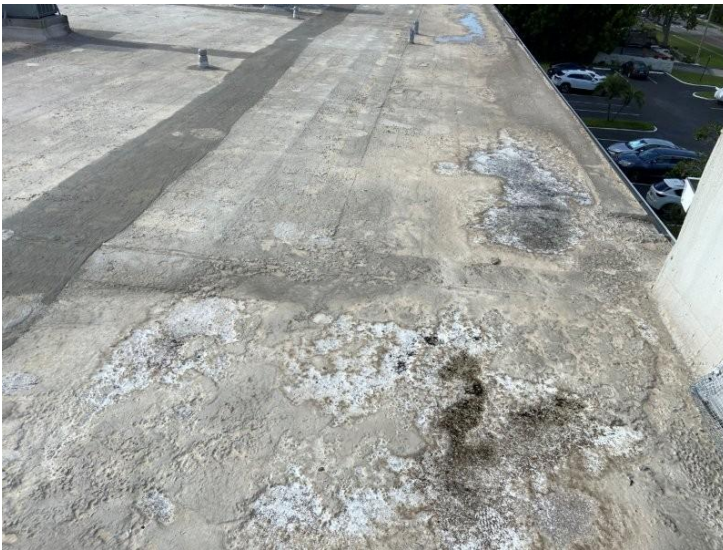
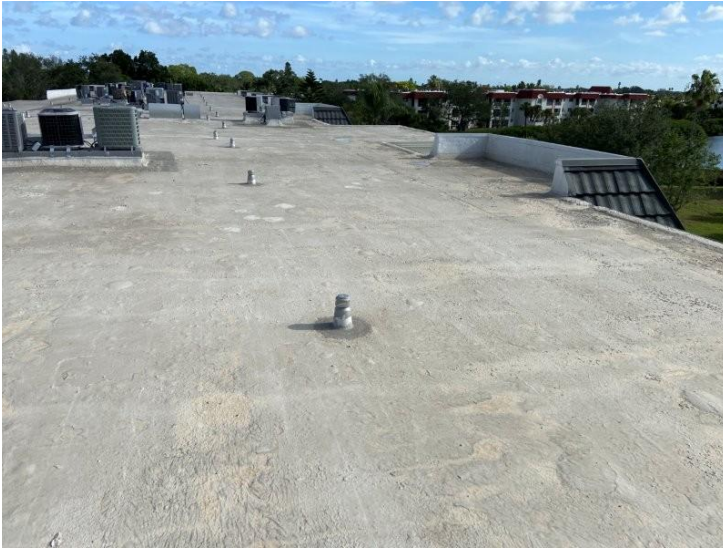
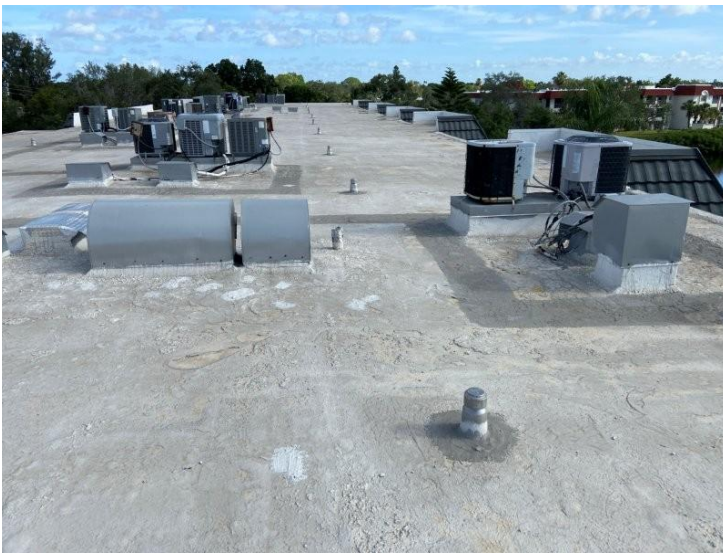
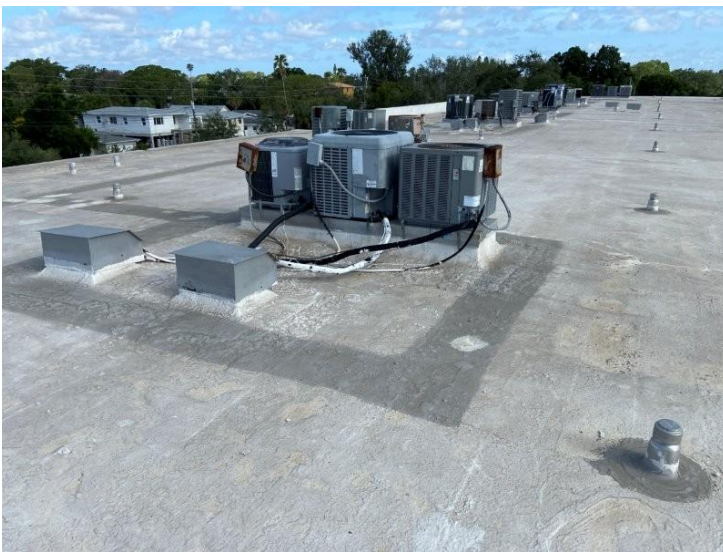
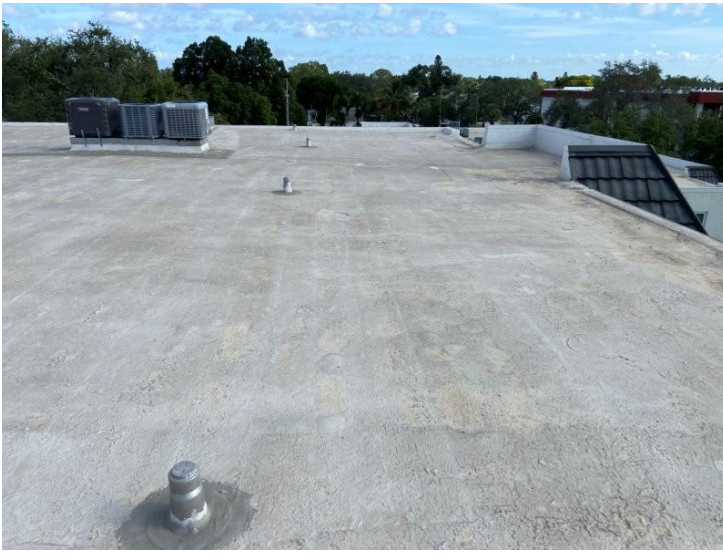
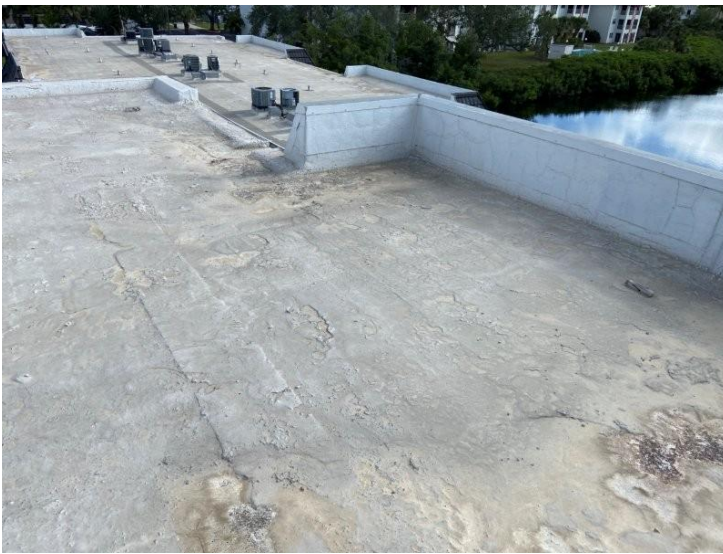
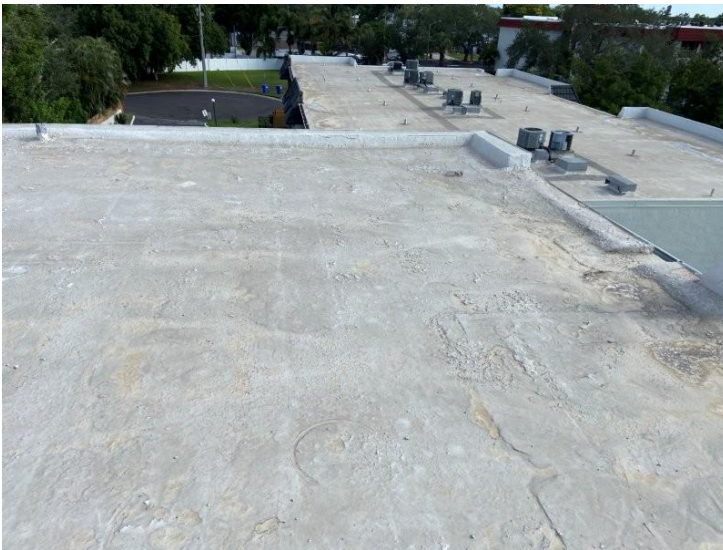
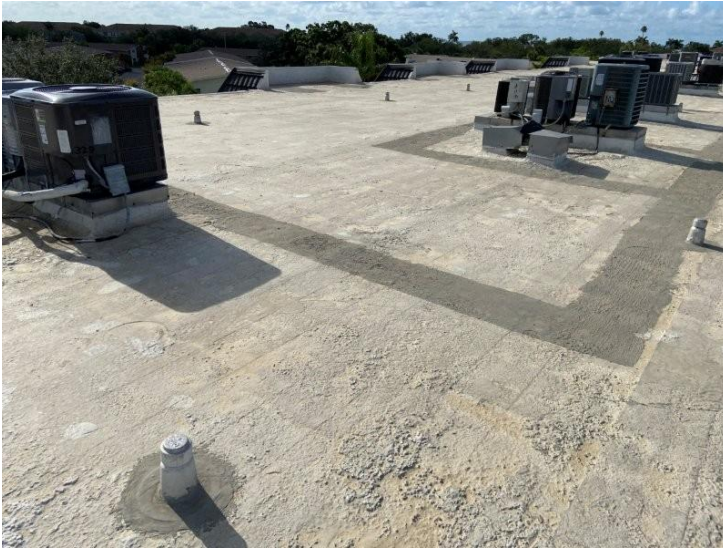
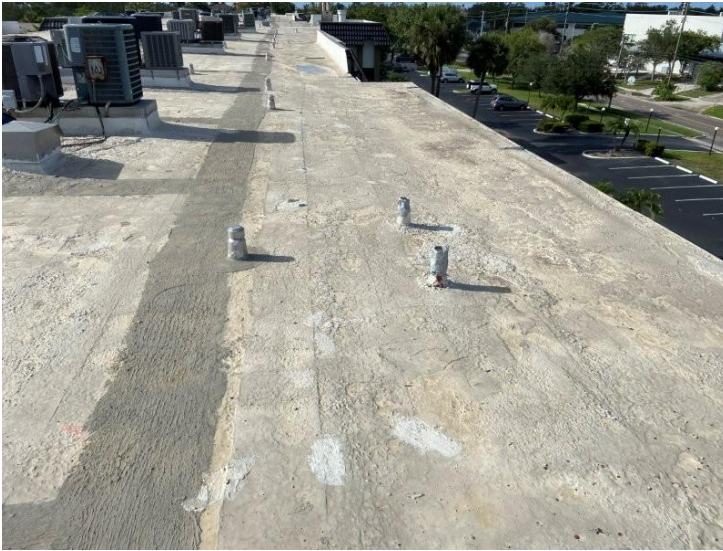
Roof Construction

| <b>5. Roof Deck Attachment:</b><br>Comments: | <b>F. Other</b><br>Inspection verified a roof deck composed of lightweight gypsum planks supported by steel bar joists. |
| <b>6. Roof to Wall Attachment:</b><br>Comments: | <b>E. Structural</b><br>Inspection verified a roof-wall connection composed of steel bar joists structurally connected to the wall/support system. |
| <b>7. Roof Geometry:</b><br>Comments: | <b>B. Flat Roof</b><br>Inspection verified a flat roof shape. |
