# Windstorm Mitigation Affidavit Report

Lake Overlook Unit 4  
4601 Chancellor St NE, Units 143-146, 247-250  
St. Petersburg, FL 33703

Prepared Exclusively for Lake Overlook Unit 4 Association, Inc.  
As of 06-15-2026 | FPAT File# MUD2627086

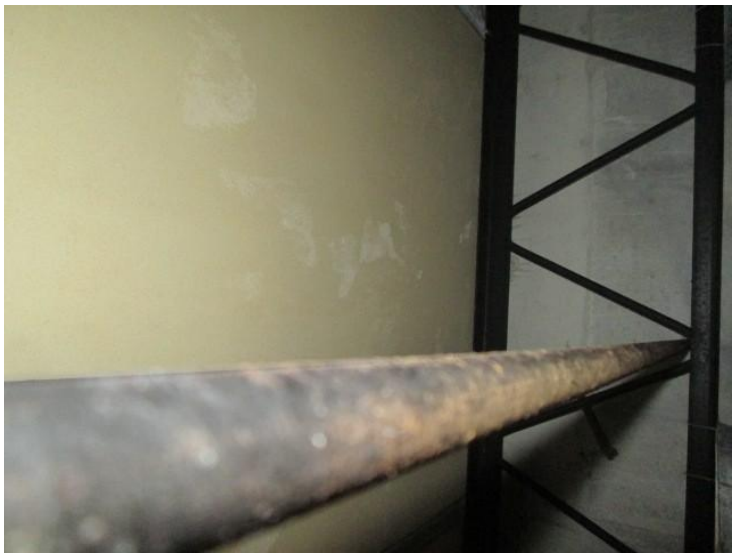
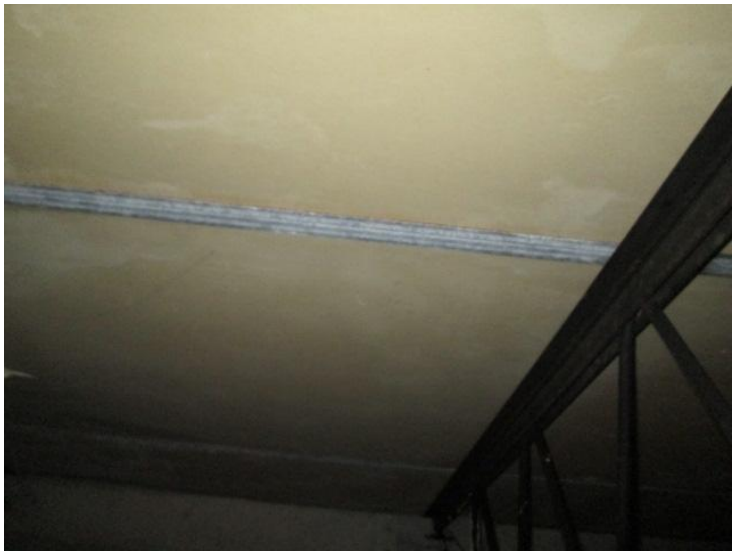
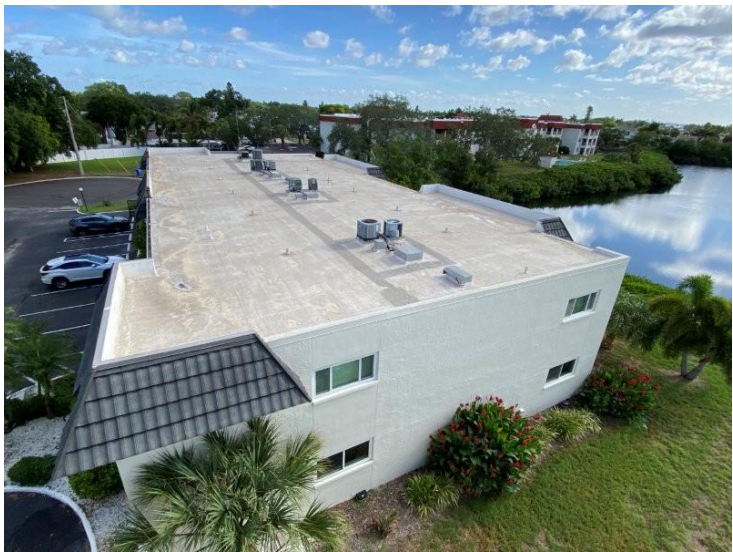
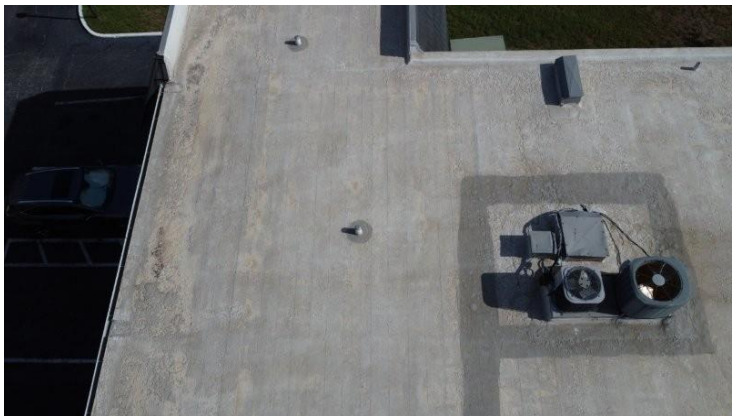
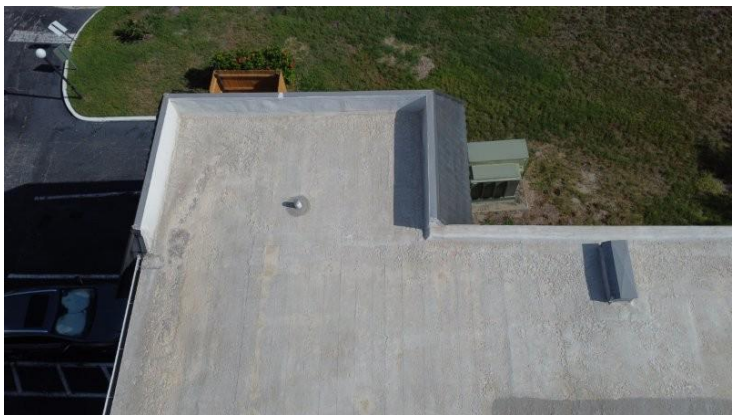
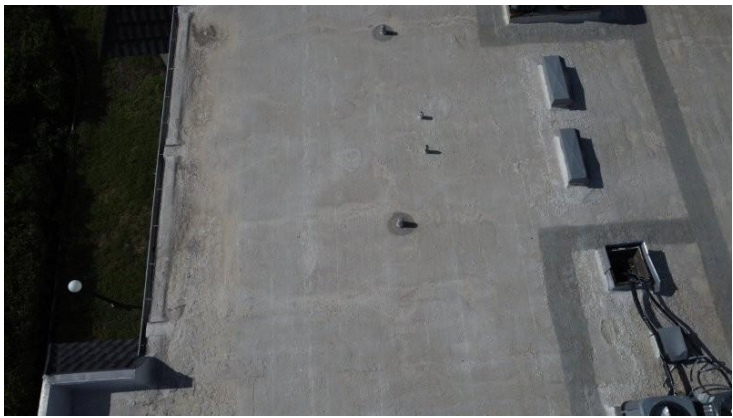
Roof Construction

| <b>5. Roof Deck Attachment:</b><br>Comments: | <b>F. Other</b><br>Inspection verified a roof deck composed of lightweight gypsum planks supported by steel bar joists. |
| <b>6. Roof to Wall Attachment:</b><br>Comments: | <b>E. Structural</b><br>Inspection verified a roof-wall connection composed of steel bar joists structurally connected to the wall/support system. |
| <b>7. Roof Geometry:</b><br>Comments: | <b>B. Flat Roof</b><br>Inspection verified a flat roof shape. |
